FINAL REPORT ON  
REMOVING WRECK OF BATTLESHIP "MAINE"  
FROM HARBOR OF HABANA, CUBA

WITH A LETTER FROM THE CHIEF OF ENGINEERS  
FINAL REPORT OF A SPECIAL BOARD OF ENGI-  
NEER OFFICERS ON RAISING AND REMOVING  
THE WRECK OF THE U. S. BATTLESHIP  
"MAINE" FROM THE HARBOR  
OF HABANA, CUBA

# REPORT OF SPECIAL BOARD OF ENGINEER OFFICERS ON RAISING THE U. S. S. "MAINE" FROM HARBOR OF HABANA, CUBA.

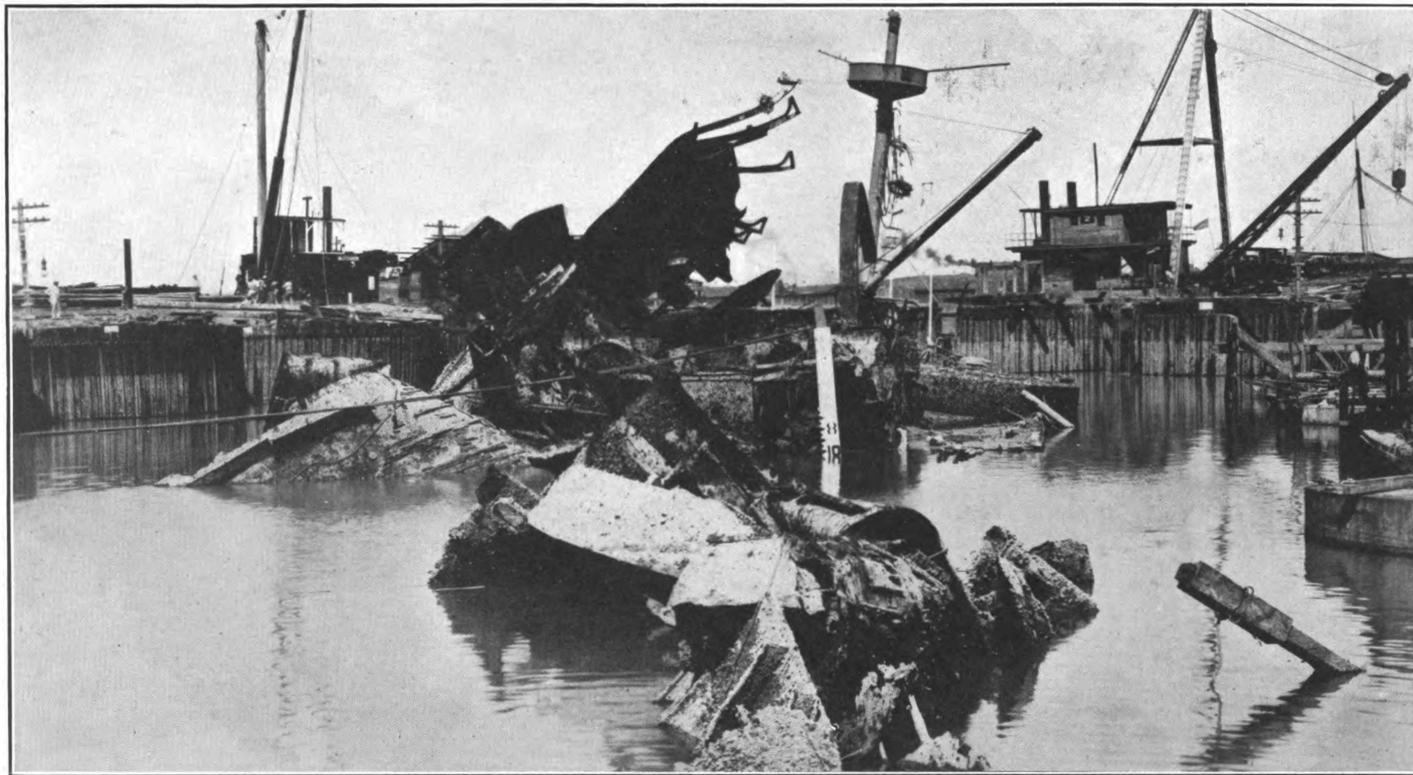
PLATE 30.—BOW WRECKAGE JUNE 16, 1911. WATER LEVEL -10 FEET.

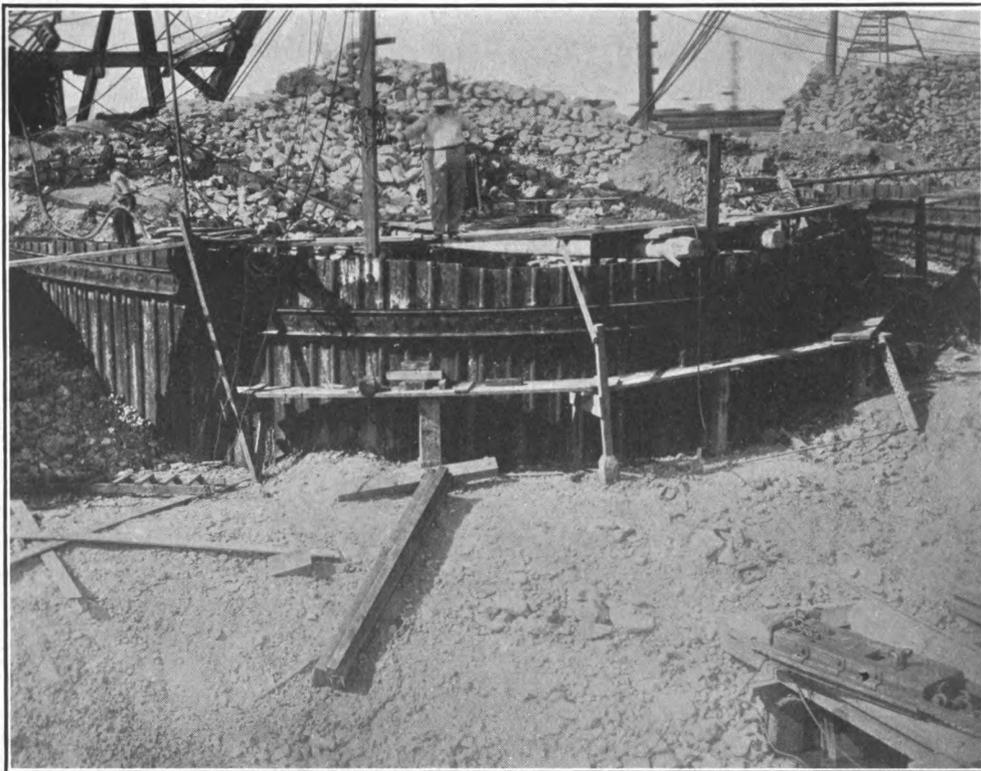
PLATE 37.—CYLINDER G, SHOWING BAND ON TOP AND FIRST PILE SUPPORT FOR BRACE G-O,  
SEPTEMBER 6, 1911.

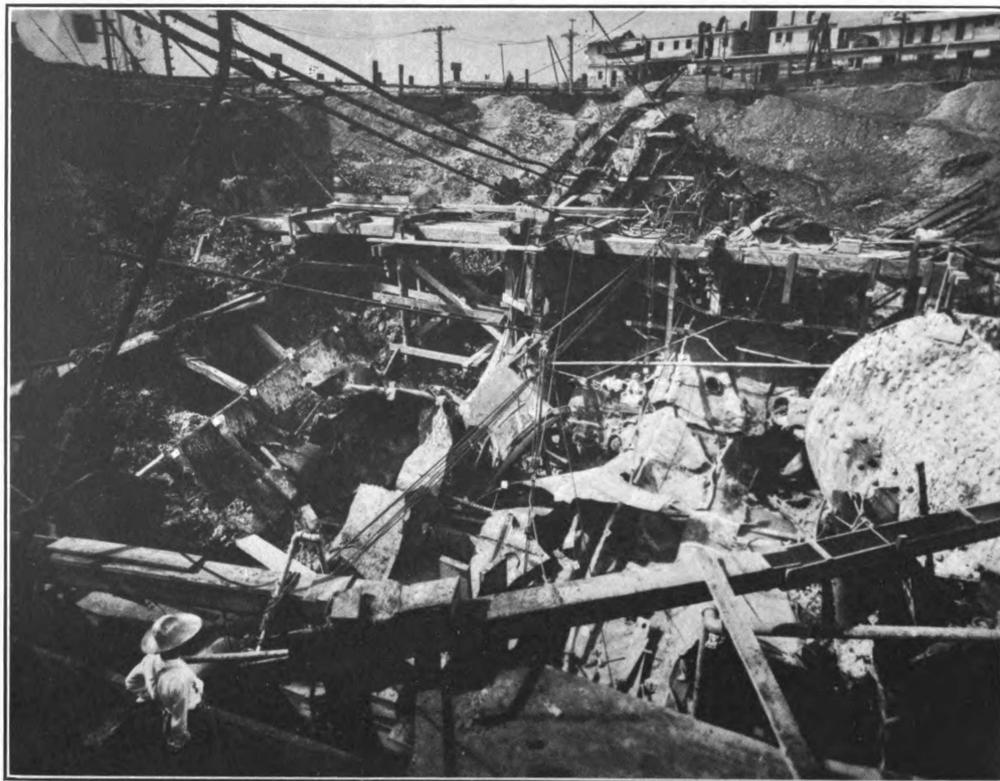
PLATE 38.—GENERAL VIEW OF WRECKAGE FORWARD OF FRAME 41 NOVEMBER 5, 1911. LINE OF KEEL MARKED IN WHITE.

67. As the unwatering and excavation progressed the condition of the wreck could be determined. An examination of plate 3 will show the location of the transverse frames or floor plates between the inner and outer bottoms. Frame No. 41 was nearly amidships, beneath the bulkhead between the forward and after boiler rooms. Frame No. 30 was under the bulkhead separating the forward boiler room from the forward magazines, 44 feet forward from frame 41. Frame No. 18 was beneath the forward bulkhead of the forward 6-inch magazine, 48 feet forward from frame 30. The foremast rested on the protective deck immediately aft of this bulkhead.

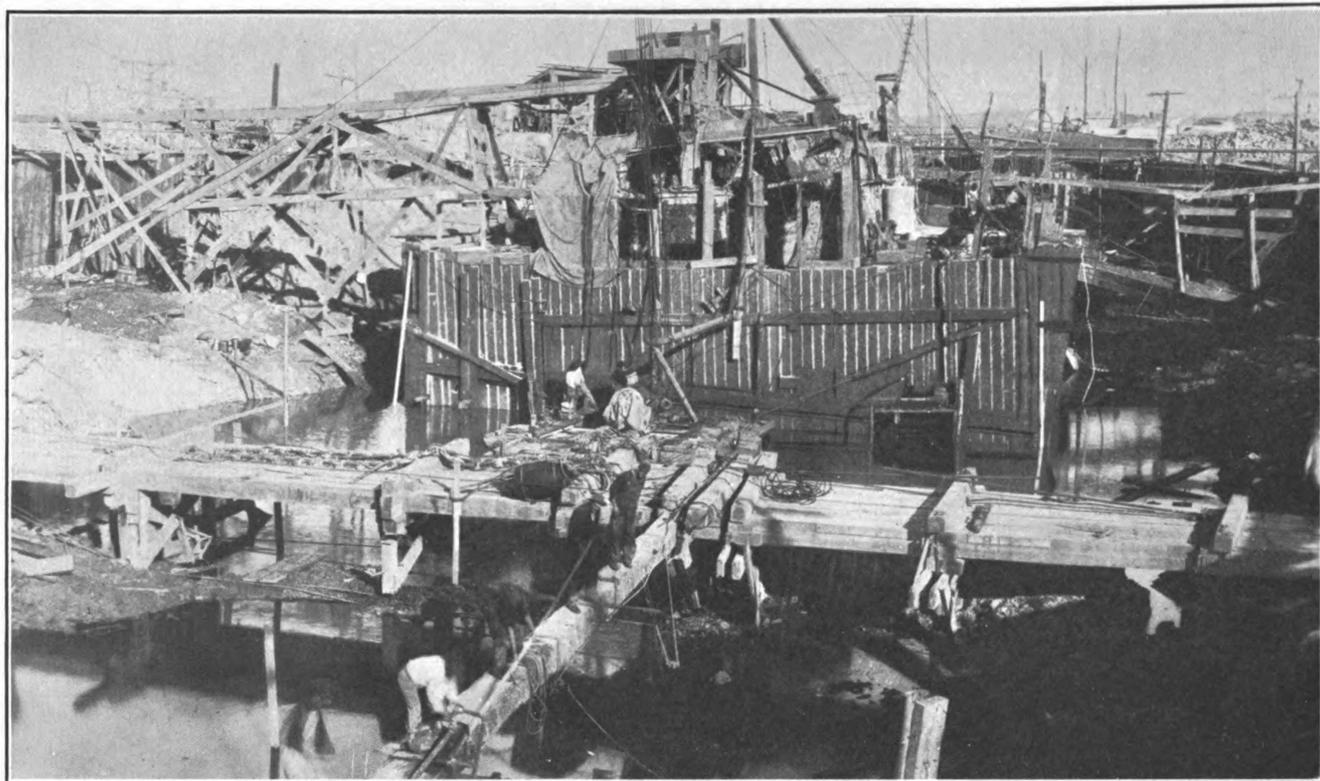
PLATE 41.—BRACE G-O AND BULKHEAD AT FRAME 41 FEBRUARY 11, 1912.

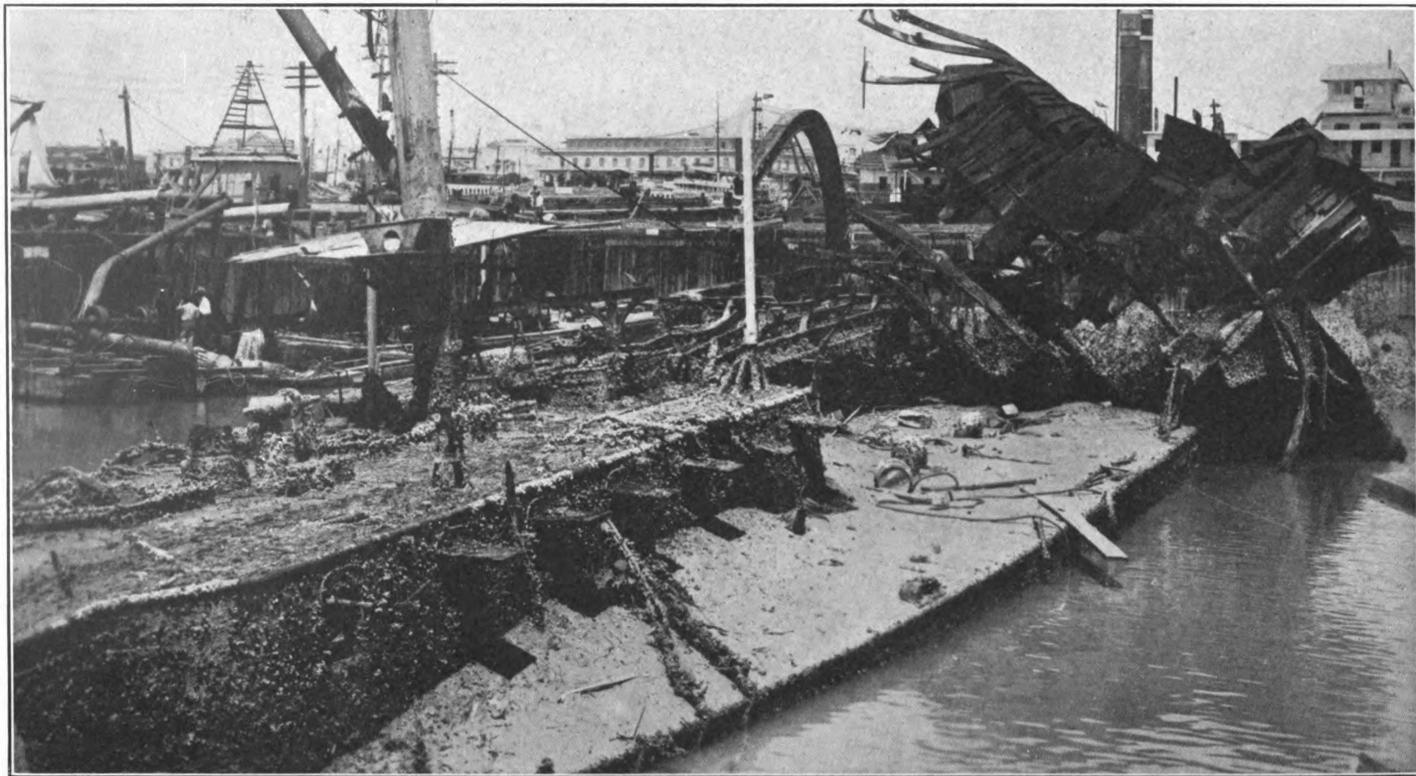
PLATE 47.—STARBOARD SIDE OF WRECK AFT OF FRAME 41, AS FIRST EXPOSED, JUNE 16, 1911. WATER LEVEL -10 FEET.

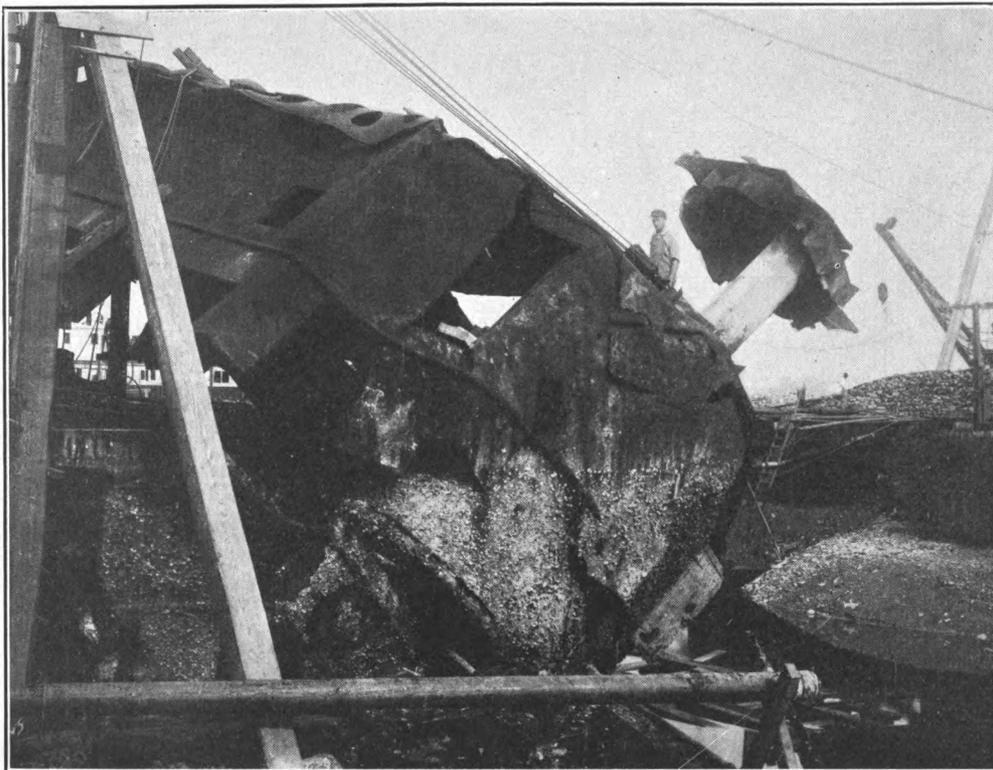
PLATE 59.—CONNING TOWER FROM AFT, SHOWING PORTION OF BASE CUT AWAY, AUGUST 15, 1911

exterior diameter), with walls 5 inches thick (see pl. No. 59), was cut by an expert operator in 58 minutes, and the wedge-shaped slot varied from about  $2\frac{1}{4}$  inches to  $2\frac{1}{4}$  inches at the head and was never more than one-eighth inch at the point. For all cutting by this process, the metal *must* be clear of rust on the starting face, and if possible, on both faces. When two thicknesses of plate were bolted or riveted together, and rust had accumulated between them, the cost of cutting was increased by about 50 per cent. The flame from the torches has no effect upon rust and little effect upon timber.

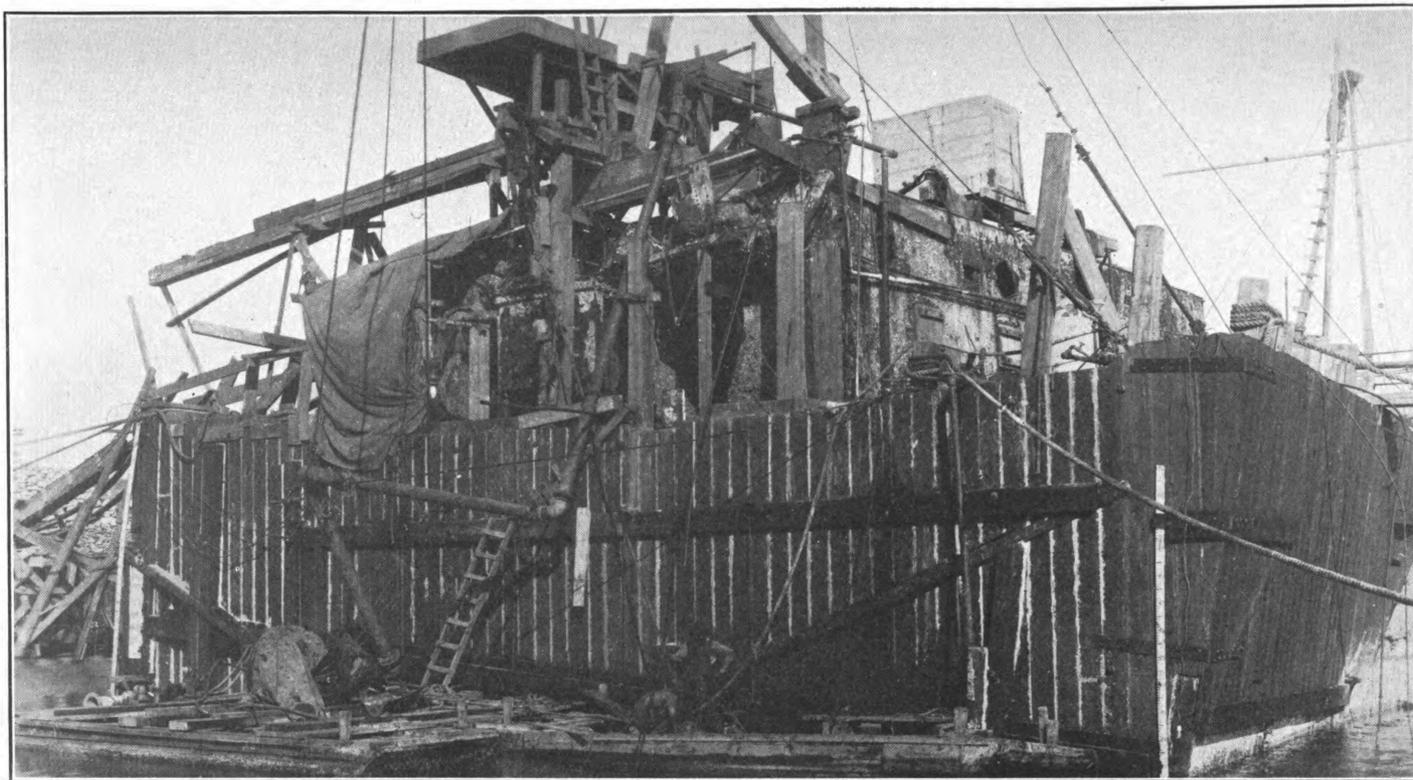
84. As soon as the wreckage and mud were sufficiently removed, the construction of a wooden athwartship bulkhead was begun at frame 41. (See Pls. Nos. 41 and 60.) It was composed of a single thickness of 3-inch plank, placed vertically and supported against 10 by 10 inch horizontal timbers (spaced to suit the water pressures), which were in turn backed by 10 by 10 inch verticals, spaced from 3 to 5 feet centers and braced to the framing of the ship, to the adjacent boilers, and to such other points as would afford good support. The tops of the planks were made about flush with the main deck, and the bulkheading was carried around the sides above the armor belt as far as the plating had been blown out. The bottoms of the planks were spiked to a sill bolted to the bottom plating and backed with concrete, and the horizontal timbers supporting the plank were X-braced, as were also some of the short back struts. Where necessary, weak points were supported by concrete or cement mortar, and especial care was taken to make water-tight all joints between the

PLATE 60.—BULKHEAD AT FRAME 41 AND ALONG PORT SIDE FEBRUARY 12, 1912.

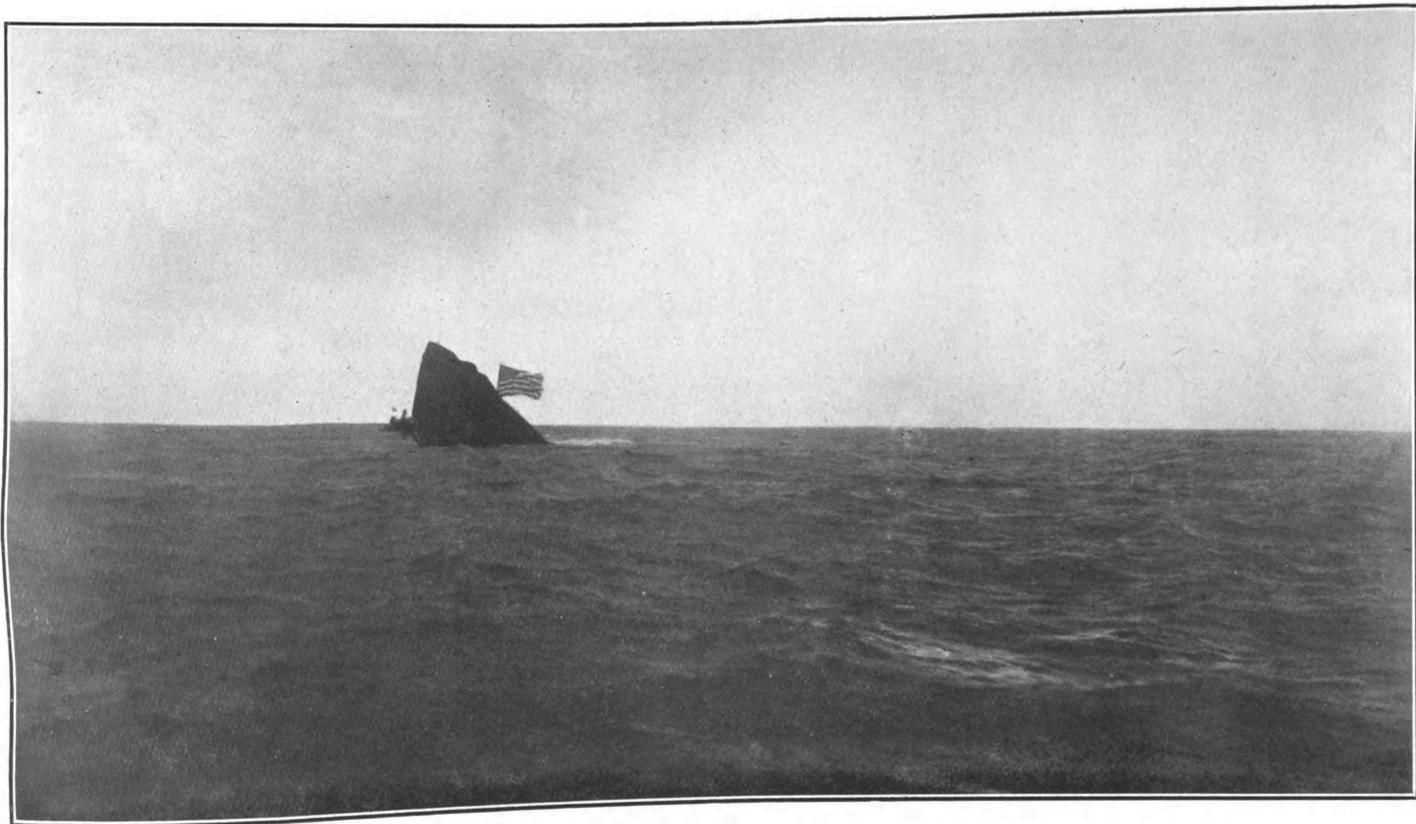
PLATE 68.—LAST VIEW OF WRECK 5.21 P. M. MARCH 16, 1912.

sives in order to admit the water. The wreck disappeared from sight 41 minutes after the opening of the valves and gates was completed. (Pl. No. 68.) The depth of water at the site where the wreck disappeared is given by the charts as 620 fathoms.
