FINAL REPORT ON  
REMOVING WRECK OF BATTLESHIP "MAINE"  
FROM HARBOR OF HABANA, CUBA

WITH A LETTER FROM THE CHIEF OF ENGINEERS  
FINAL REPORT OF A SPECIAL BOARD OF ENGI-  
NEER OFFICERS ON RAISING AND REMOVING  
THE WRECK OF THE U. S. BATTLESHIP  
"MAINE" FROM THE HARBOR  
OF HABANA, CUBA

# REPORT OF SPECIAL BOARD OF ENGINEER OFFICERS ON RAISING THE U. S. S. "MAINE" FROM HARBOR OF HABANA, CUBA.

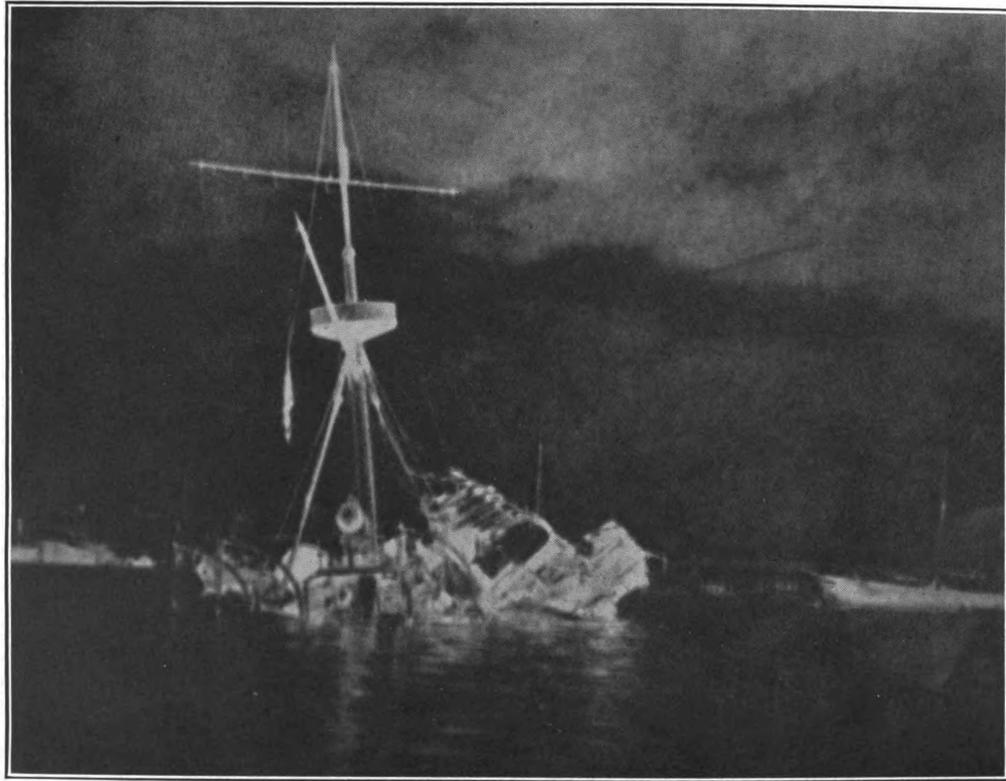
PLATE 4.—"MAINE" AT SUNRISE FEBRUARY 16, 1898.

3. About 9.40 p. m., February 15, 1898, the *Maine* sank at her moorings as a result of an explosion, which immediate investigation showed had destroyed a large portion of her hull from about amidships forward. Two officers and 258<sup>1</sup> enlisted men of the crew perished, including those who died of wounds shortly after the explosion. The bodies of 1 officer and of 74<sup>1</sup> of the men were supposed to have been entombed in the wreck. Plate No. 4 shows the appearance of the wreck on the morning of February 16.

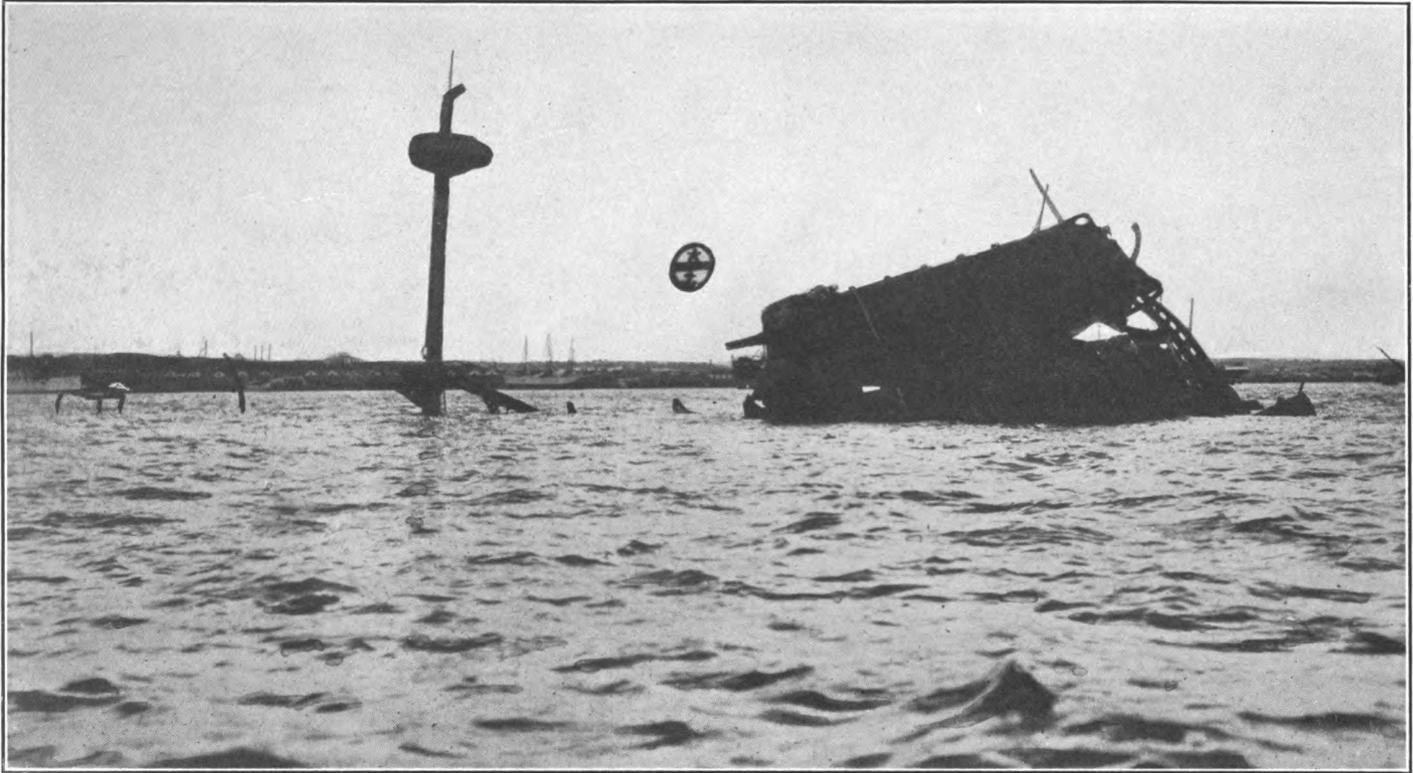
PLATE 6.—APPEARANCE OF WRECK SEPTEMBER, 1910.

8. As stated earlier in this report, the *Maine* was originally 324 feet long and her maximum width was 57 feet. It was known that the forward part of the vessel had been badly shattered, that pieces of wreckage were scattered over a considerable area of the bottom for many feet on each side of the line of the keel, and that the wreck had settled in the soft mud until the keel, or at least its after half, was certainly not less than 42 feet below the water surface. Plate No. 6 shows the appearance of the wreck when the work of the board began.

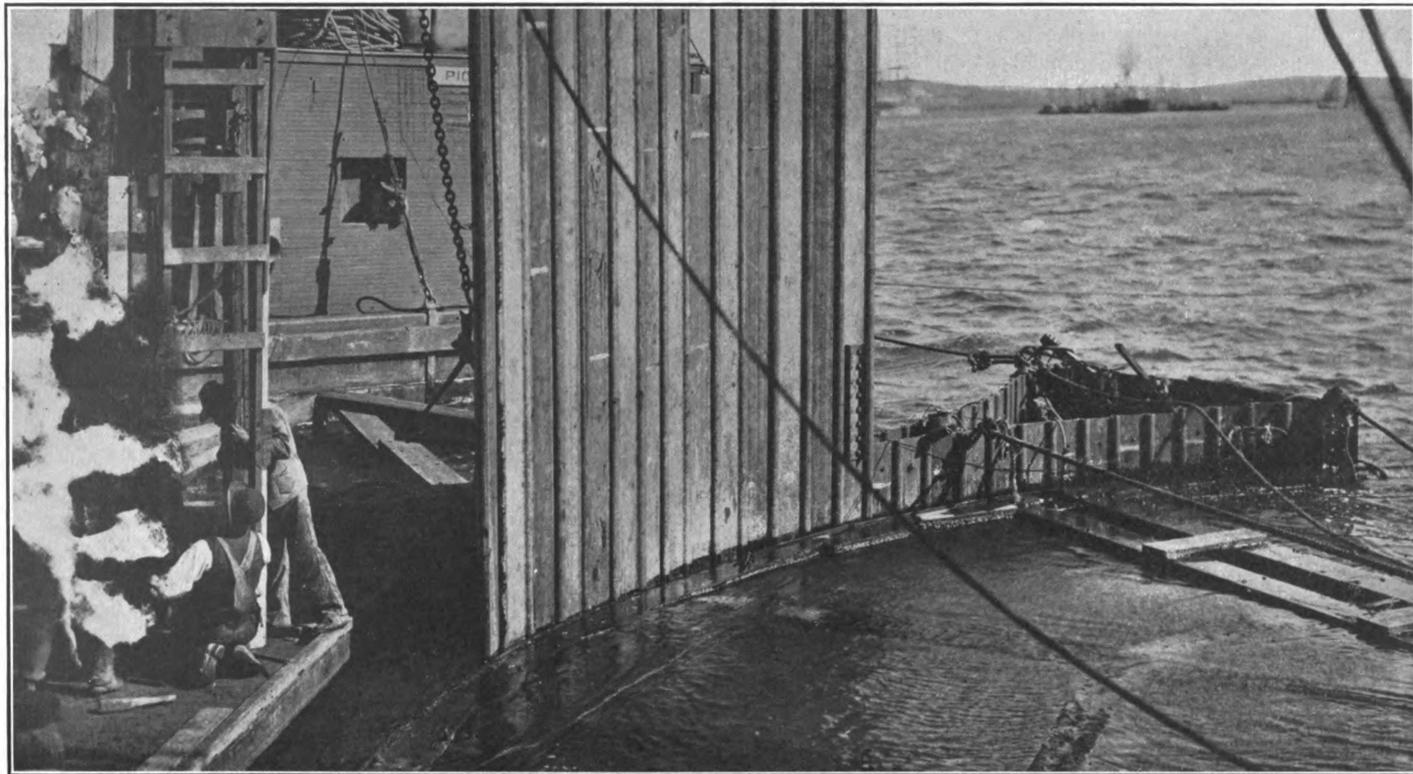
PLATE 12.—COMPLETED ARC AND PARTLY DRIVEN CYLINDER PILES SHOWING FALSE LEADS FOR STEAM HAMMER.

24. The actual placing in position of the bottom sections of piling, counting from the time when the pile was ready to be hoisted from the barge until it was finally placed, averaged 6 minutes. Placing the top sections in readiness for making the joint, counting from the same stage of the operation, took an average of 5 minutes. Making the joint took an average of about 10 minutes, as but two men could work at a time, and to secure the desired stiffness it was necessary to set up the nuts very tightly. It was found later that the driving loosened many of these nuts, no matter how tightly they were set up, and thereafter some additional time was consumed in upsetting the bolt threads to prevent the nuts being started by the driving. The actual driving of the piles, except the closure piles, took an average of four minutes each. For driving the piles there were used two No. 3 Arnott, one Vulcan, and one Monarch steam hammers, the first-named weighing 3,700 pounds and the Vulcan and Monarch hammers somewhat more. The tops of the piles when in position and ready to be driven were often as much as 40 feet above water, and it was difficult to set and hold the steam hammers on the piles at such a height. Several different kinds of false leads were improvised, as shown on the accompanying photographs, and they aided greatly in handling the hammers. These false leads are shown in plates 12, 15, 17, 18, 19, and 20.

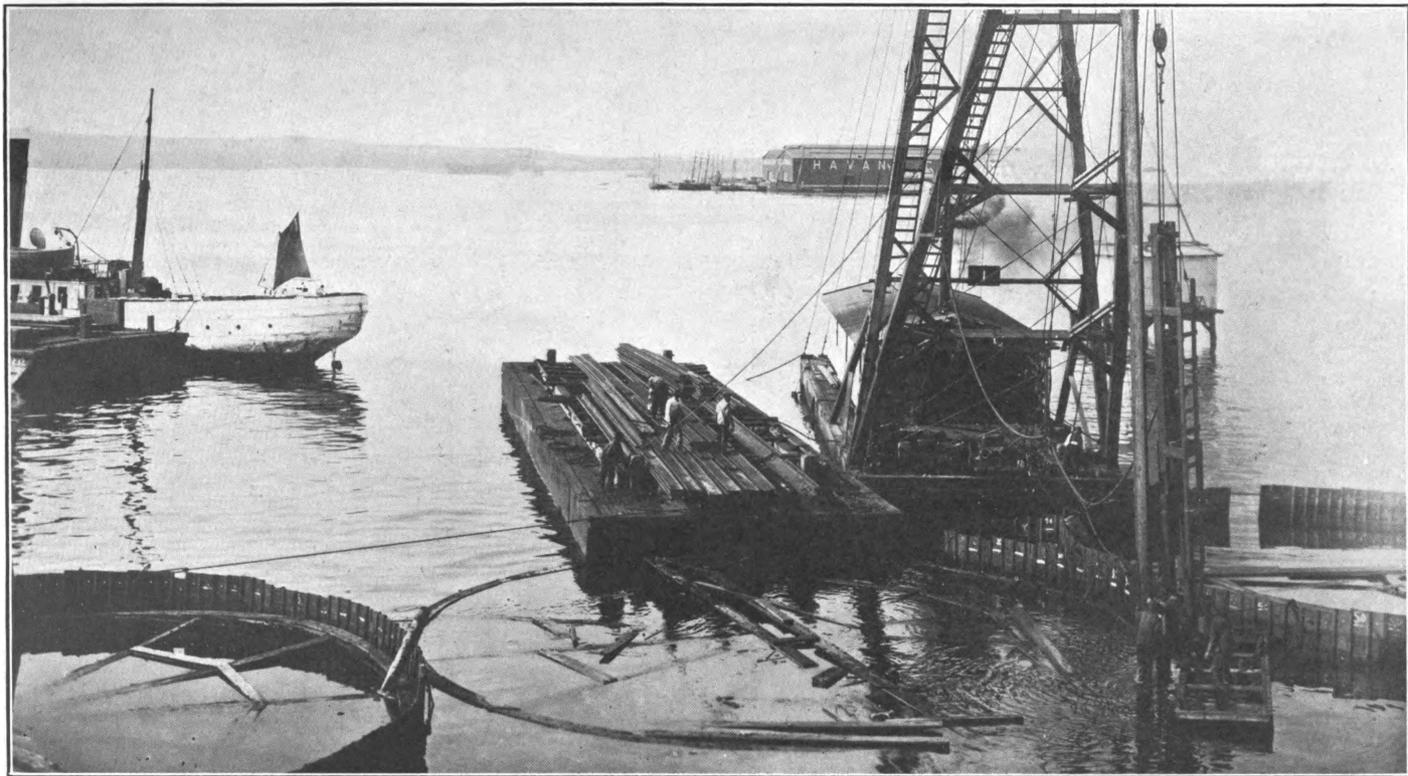
PLATE 15.—STARTING A CYLINDER.

20. Later it was found practicable to drive the piles as they were placed, until there remained an interval to be filled by about 10 piles, the bottom sections of which were then set in place, and the closure made with about 5 undriven piles on each side of the closing pile. There was sufficient play in the interlocks of these 10 undriven piles to permit this method to be followed. In this latter method of driving the piles as placed, the undriven bottom was held to the last driven pile by a chain or wire until the joint could be made. (See pls. 15, 16, 17, and 18.)

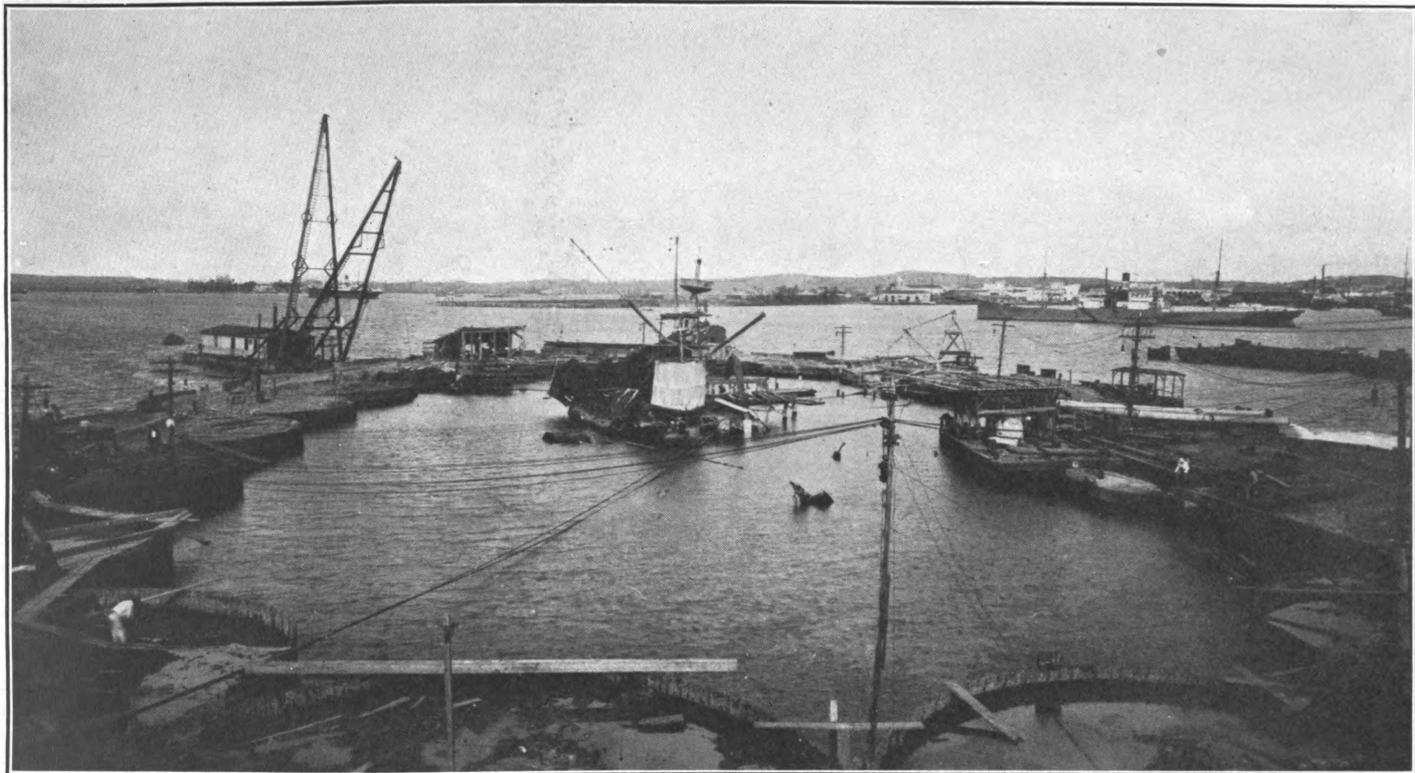
PLATE 26.—GENERAL VIEW OF COMPLETED COFFER DAM, PUMPING JUST STARTED.

37. The first pumping was done on June 2, 1911, for the purpose of testing the pump, before the rebuilding of cylinder N had been quite completed, the water within the dam being lowered about 1 foot. Regular pumping began on June 5, using only the 8-inch pump. (See pl. 26.) The water level was lowered from  $-0.75$  to  $-2.45$  in 7 hours, and the leakage was sufficient at that time to raise this water level about 0.03 foot per hour when the pump was stopped. The level was further reduced to  $-5$  feet on June 6 in  $12\frac{1}{2}$  hours, net time. (See pl. 27.) It was planned to lower the level inside of the dam in successive stages of about 5 feet, holding it at each level until the fill in the cylinders could be drained and dried out. It was also decided to remove the filling from the inner half of each cylinder and pile this material on top of that in the outer half. This was done for two reasons. It was expected that the fill would settle somewhat as it drained and dried, and the additional material piled on the outer half would compensate somewhat for the shrinkage, and its removal from the inner half would have the effect of lessening

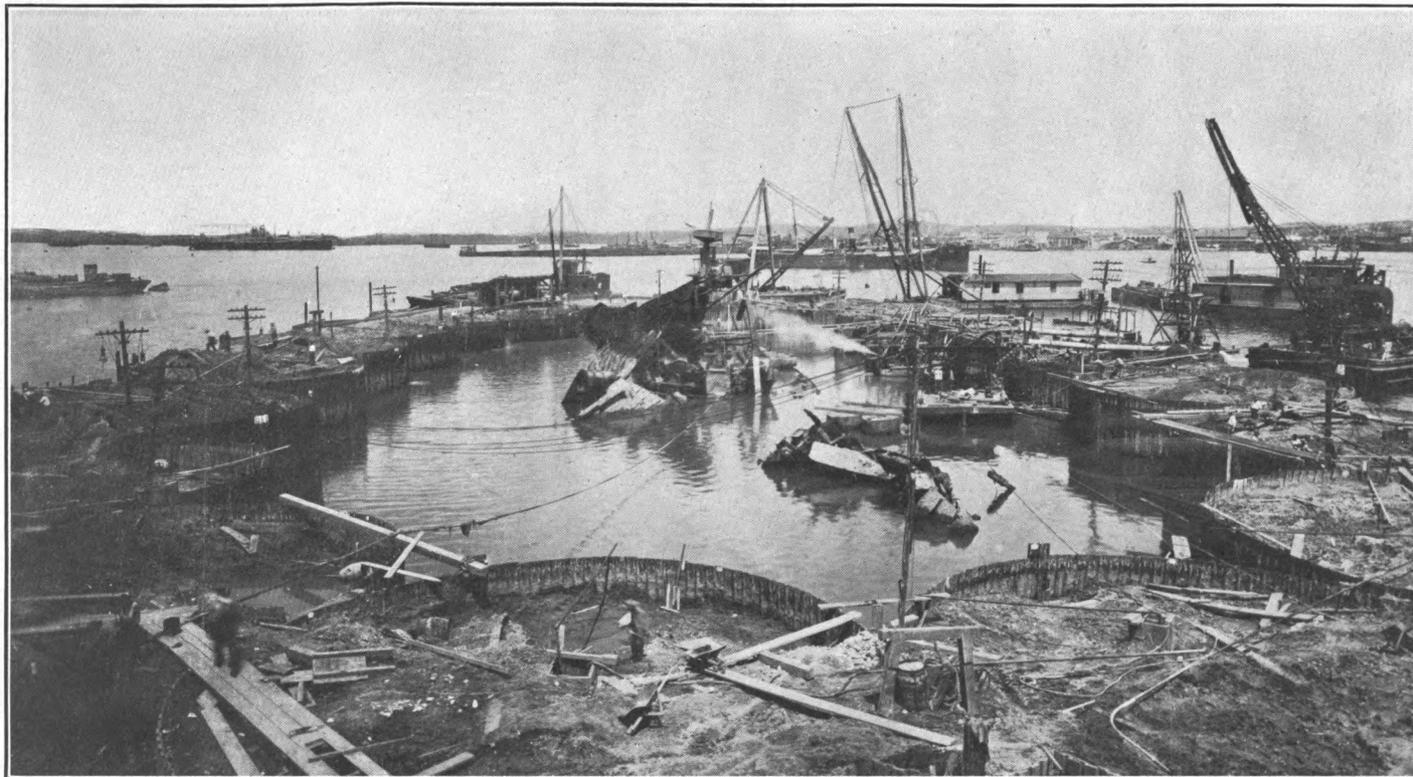
PLATE 29.—GENERAL VIEW JUNE 16, 1911. WATER LEVEL, —10 FEET.

the bursting pressure on the inner parts of the cylinders from which the opposing water pressure would be removed as the dam was unwatered. Plate No. 28 shows the extent to which this filling was shifted. The expected settlement of the fill took place. No movement of the cylinders and no deformation was noted with the water inside of the dam at about -5 feet, where it was held for 9 days, or until June 15. By the next day it had been lowered to -10 feet, and it was again further lowered to -15 feet on June 20. (See pls. 29, 30, and 31.)

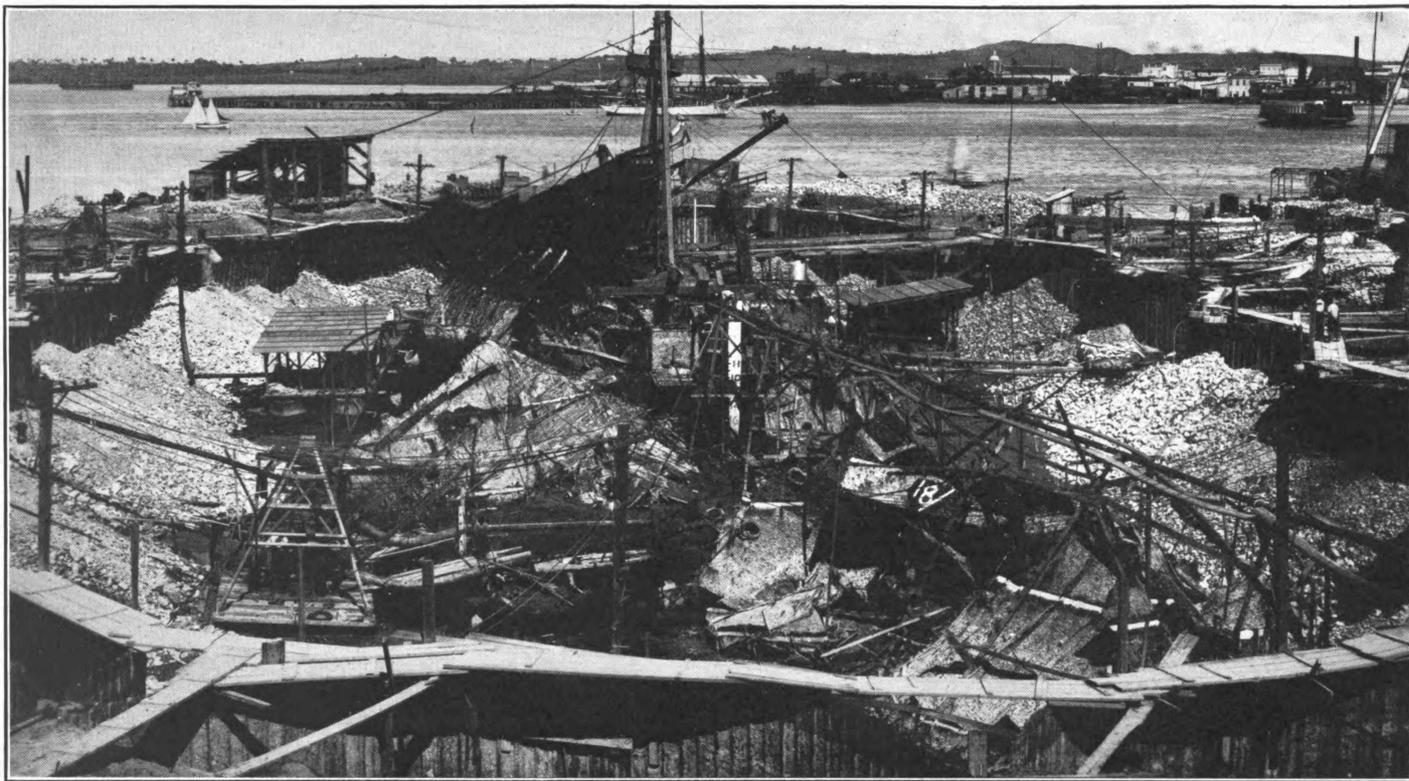
PLATE 33.—GENERAL VIEW OF WORK AUGUST 2, 1911. WATER LEVEL —22 FEET.

41. This plate shows distinctly the prompt increase in the rate of movement of the tops of the cylinders when the water level was lowered from about -16 feet on the 17th of July to about -20 feet, and then to about -22 feet by July 28. (Ordinary high tides increased the difference between the level of the water inside and outside the dam by about 1.5 feet.) This plate also shows that after a short time the rate of movement decreased appreciably, and then continued to be quite uniform. Further discussion of this movement is made later in this report. By August 5 the maximum movement inward since July 5 had been that of cylinder E, amounting to 49½ inches. It was then decided that this movement could not be allowed to continue longer unchecked, and that some means must be employed to bring the cylinders to rest. While deciding what should be done, the level of the water inside the dam was allowed to rise gradually to about -15 feet, and the effect is shown plainly on the plate. Plate No. 33 shows the appearance of the wreckage with the water at -22.

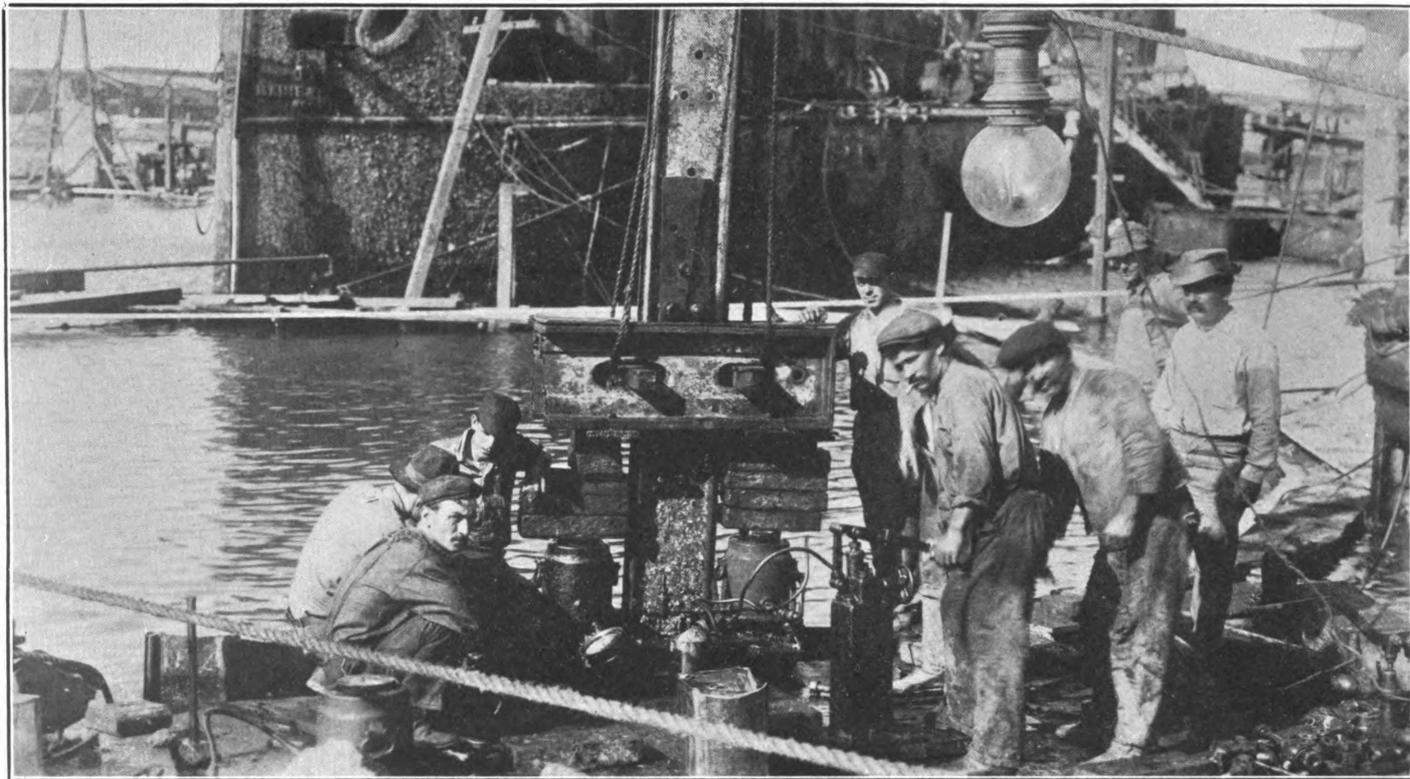
PLATE 61.—STARTING A PILE WITH JACKS, CYLINDER U, WRECK AFLOAT IN COFFER DAM FEBRUARY 21, 1912.

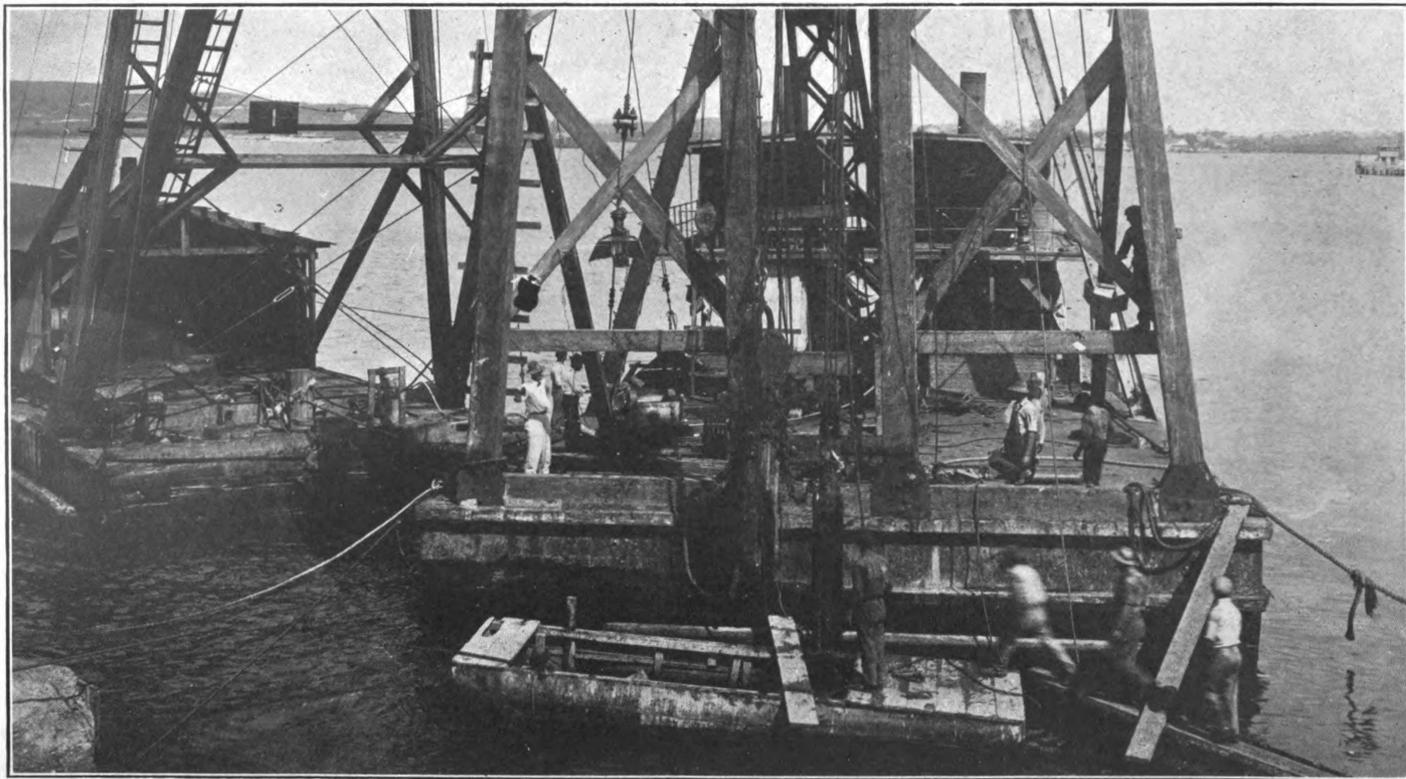
PLATE 62.—PULLING A PILE WITH FLOATING DERRICK, CYLINDER U, FEBRUARY 25, 1912.

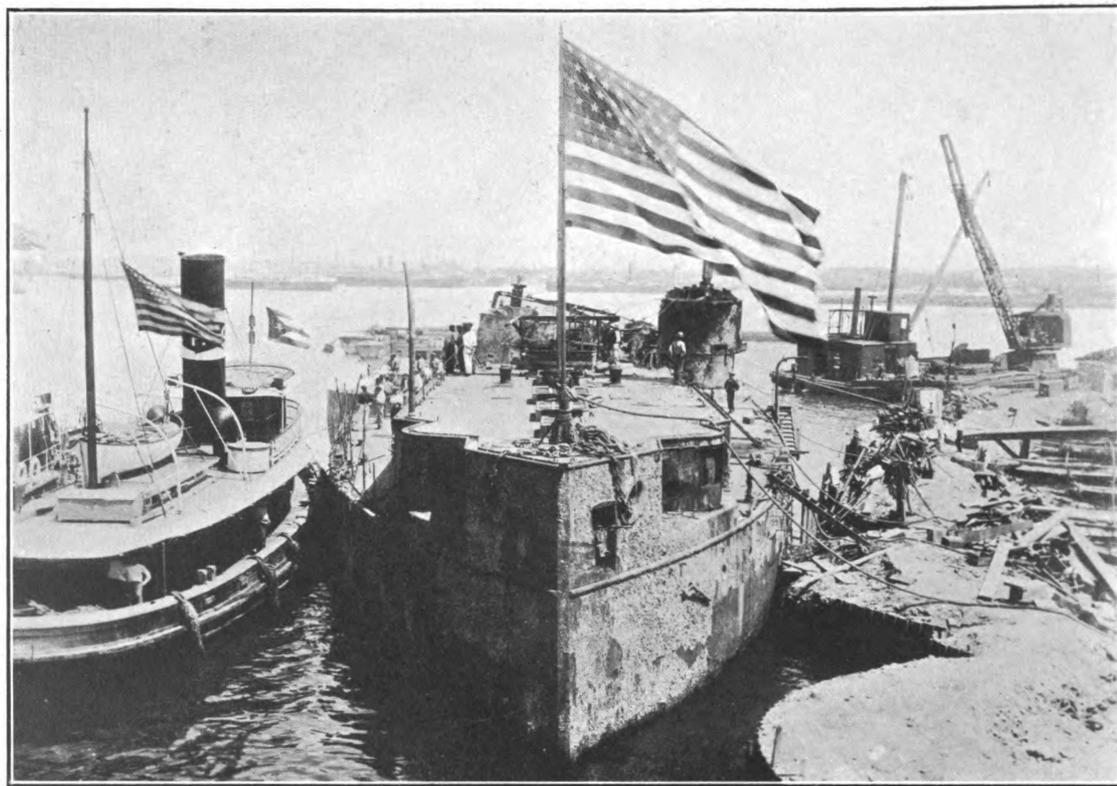
PLATE 64.—WRECK MOORED OUTSIDE OF COFFER DAM FOR REMOVAL TO SEA, MARCH 15, 1912.

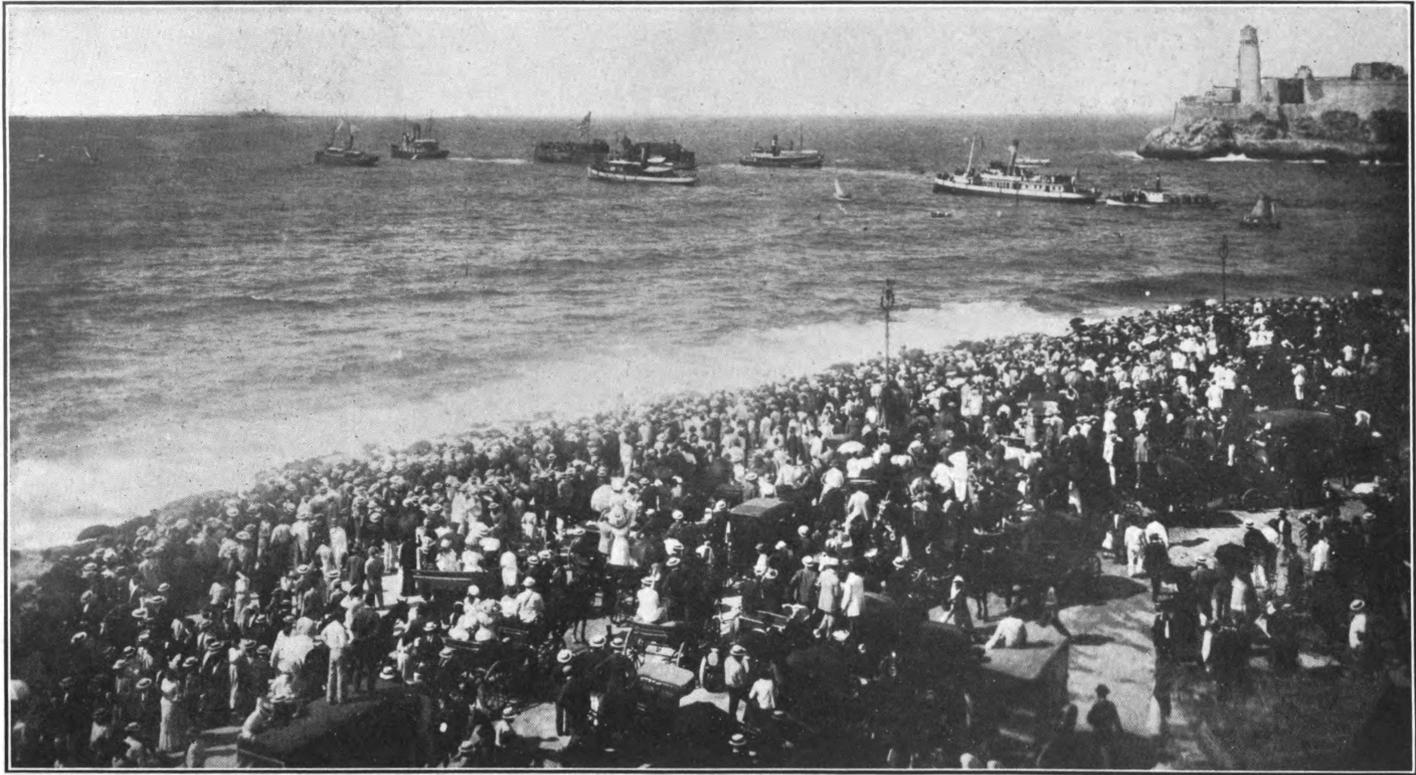
PLATE 65.—WRECK LEAVING MOUTH OF HAVANA HARBOR MARCH 16, 1912, 3 P. M.

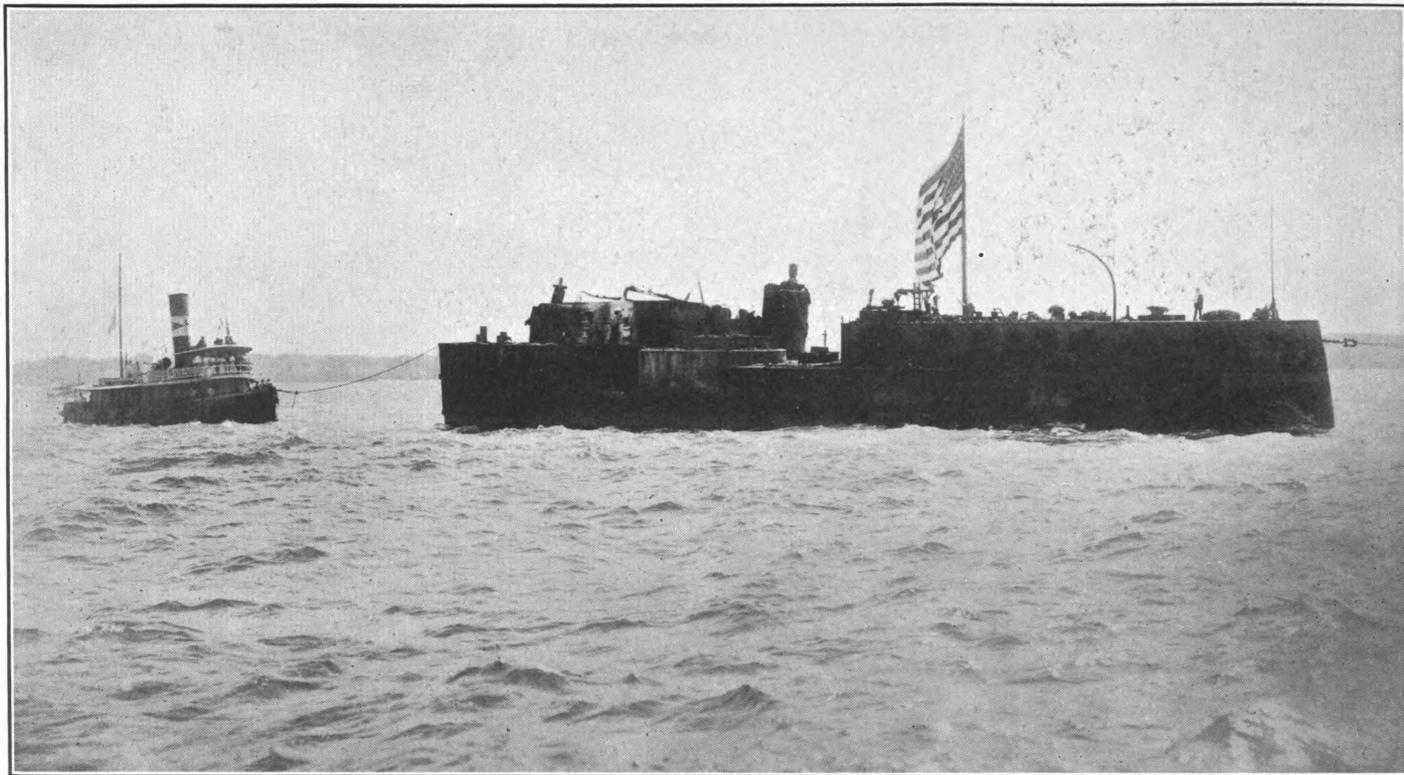
PLATE 66.—WRECK AT SEA, UNDER TOW, MARCH 16, 1912.

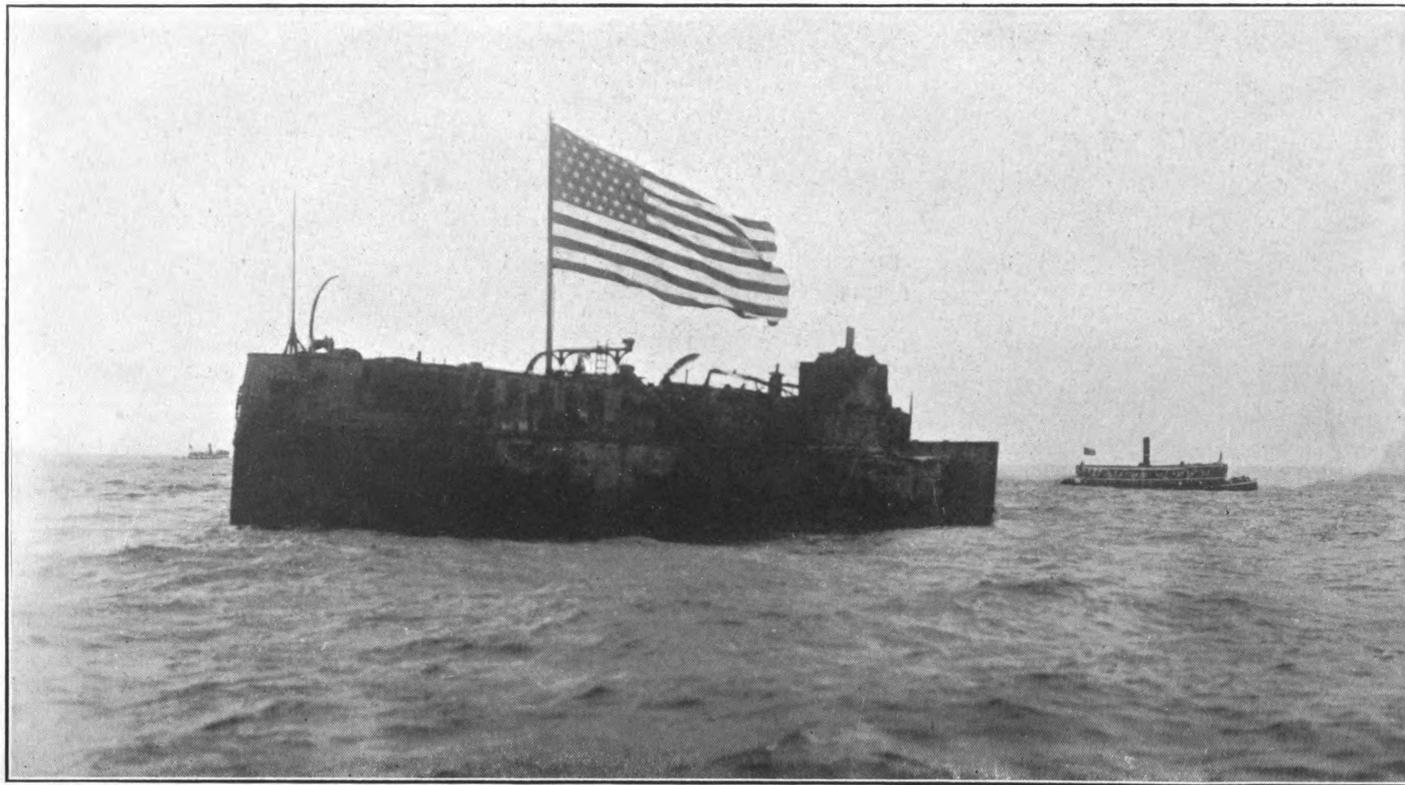
PLATE 67.—WRECK ABANDONED AT SEA BEYOND 3-MILE LIMIT 4.50 P. M. MARCH 16, 1912.

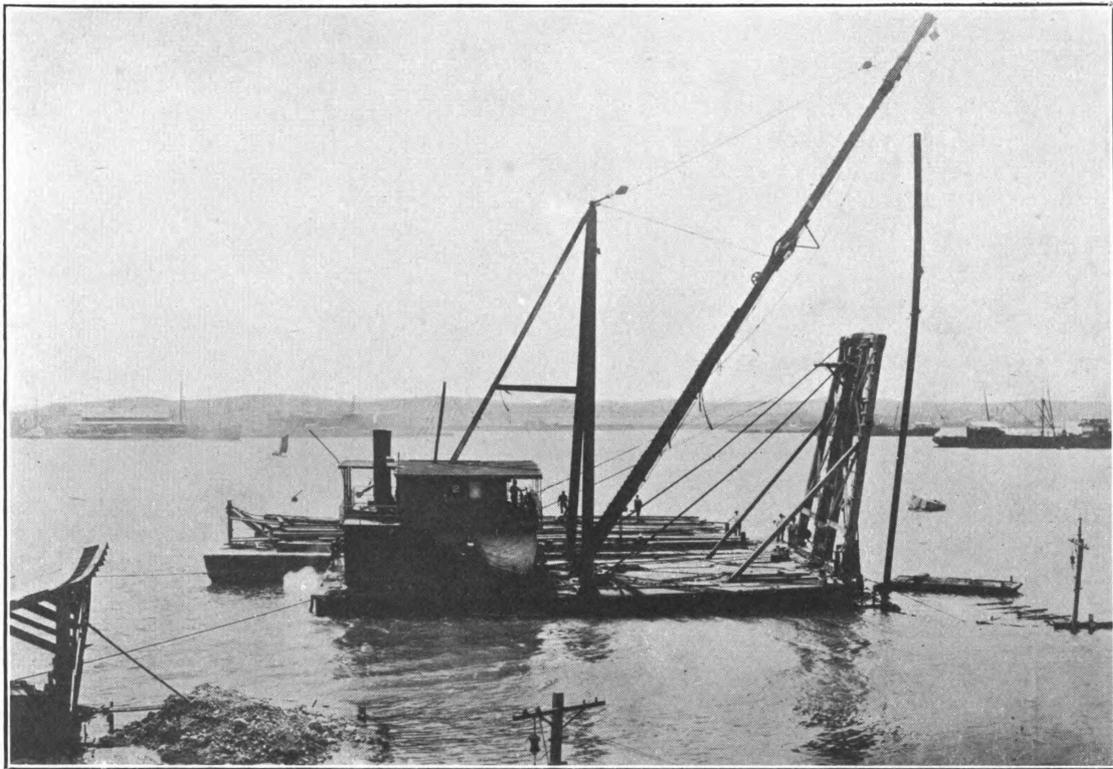
PLATE 69.—DERRICK BOAT PULLING COFFER DAM PILES, APRIL 8, 1912.
